**Midtown
Rail Station
Accessibility Assessment
N4**

Joel Anders, Arnaud Huguet, and Alex Poznanski
15 August 2012

METROPOLITAN ATLANTA RAPID TRANSIT AUTHORITY

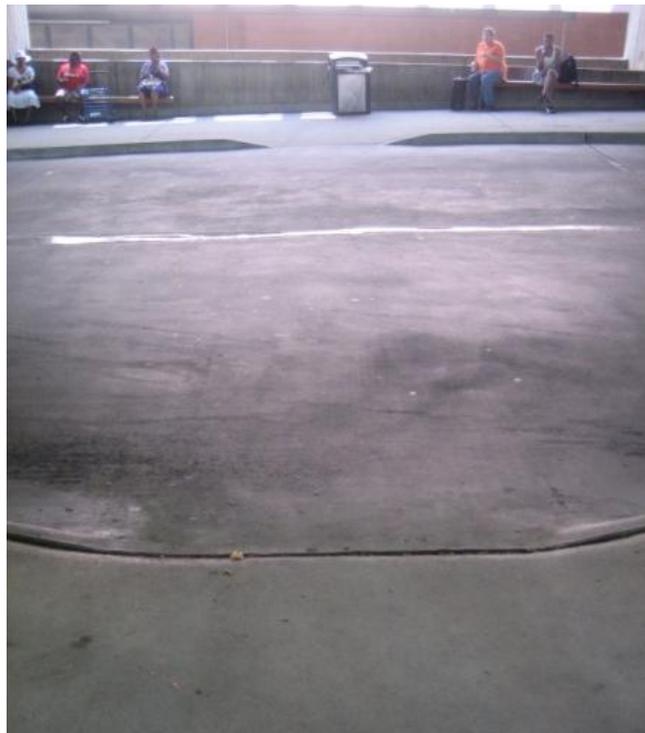
- As can be seen below in Figure 1, there is a set of ramps, which imply a crosswalk, but a ***lack of striping and truncated domes within the bus loop*** area on the west side of the Main Concourse level. This set of ramps leads from the side of the bus loop abutting the western station wall to the other side of the bus loop.

Figure 1 - Crosswalk through bus loop without striping and truncated domes (Photo 31).

- Add crosswalk striping and truncated domes to the above areas within and surrounding the station.

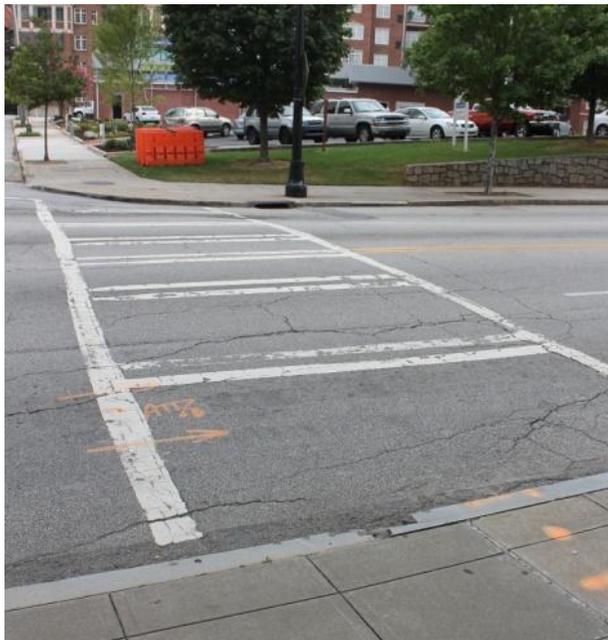
- At the intersection of 10th St. and Williams St. (the **main intersection to cross the 10th St. Bridge**), there is lack of truncated domes on all corners, except the southeast, and faded striping on the west side crosswalk (Photos 75-77).
- At the intersection of 10th St. and Crescent St., there is a crosswalk leading from Delta Community Credit Union to the Federal Reserve; however, as can be seen below in Figure 2, there is a **lack of curb cuts** and truncated domes at either end of the striping.

Figure 2 - 10th St. crosswalk that is not ADA accessible (Photo 91).

- Coordinate with the Midtown Improvement District, the City of Atlanta and/or private property owners to add proper pedestrian infrastructure (curb cuts, truncated domes, adequate ramps, crosswalk striping) to the above areas.

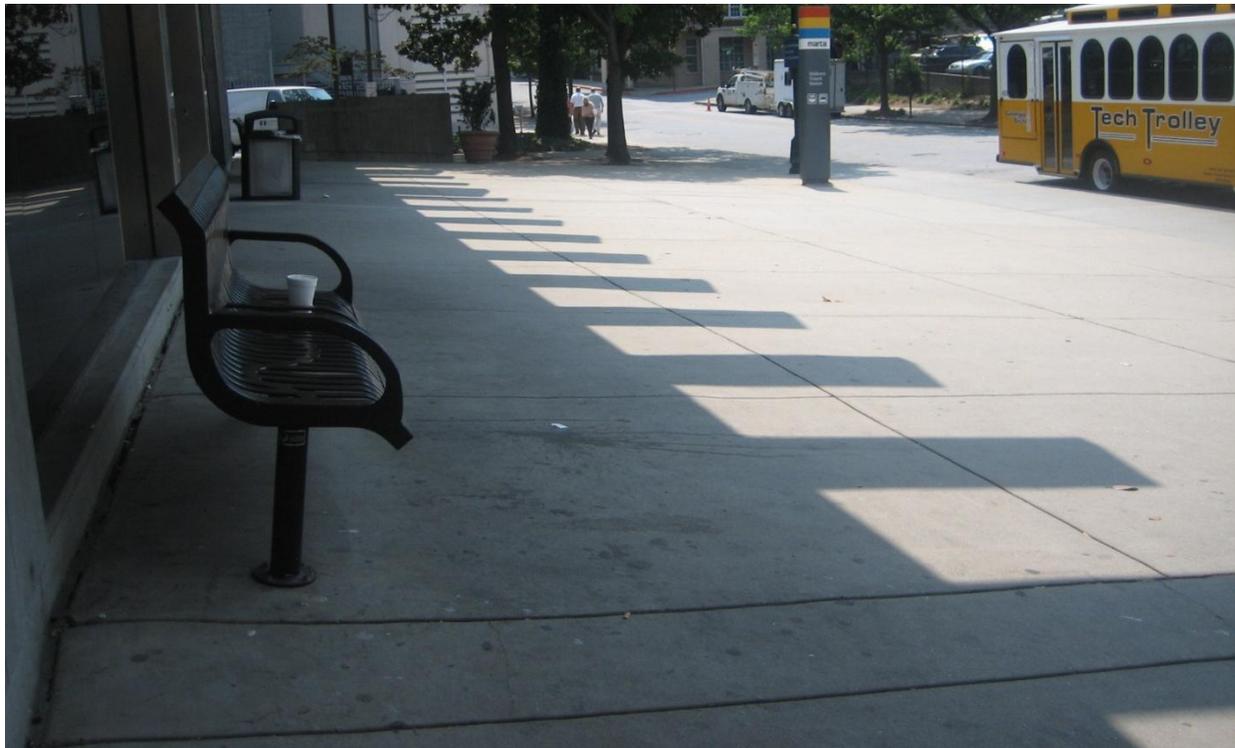
- As can be seen below in Figure 3, within the unpaid area of the south side of the Main Concourse level, there are **two benches** that, owing to the slope that travels down from the station to Peachtree Place, were placed at an uncomfortable angle and **are tilted forward**.

Figure 3 - A bench that is titled forward towards the ground (Photo 30).

- **Re-install benches** on the Peachtree Place side of the Main Concourse, such that the back face of the bench is parallel with the glass pane on the station wall.

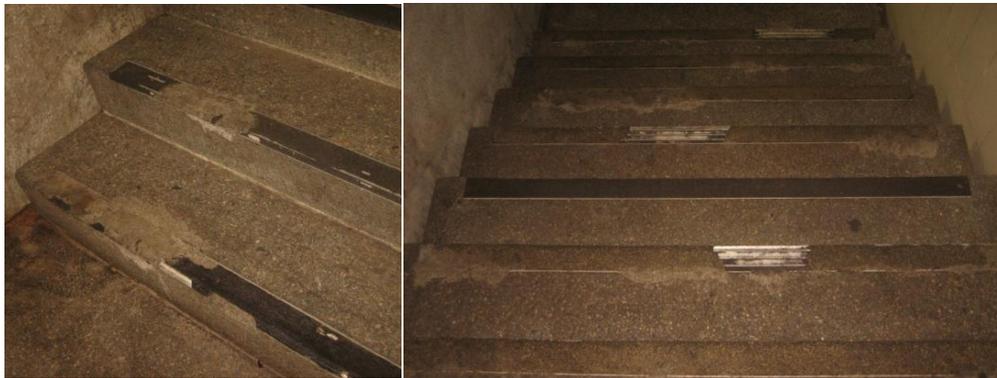
- As mentioned in the Repairs Brief and seen below in Figures 4 and 5, the majority of the **anti-slip grip strips** on each of the staircases leading from the main concourse (South of 10th St.) **are very worn and some of the steps have chunks of concrete missing** on the lip (Photos 3, 9, 13 & 23).

Figure 4 (Left) – Worn anti-slip grips and missing concrete on lip (Photo 3).

Figure 5 (Right) – Worn anti-slip grips lead to exposed metal plates (Photo 13).

- Replace anti-slip grips on all staircases.
- Fill-in missing sections of concrete on all staircases.
- Remove graffiti from corner mirror in Federal Reserve Concourse.

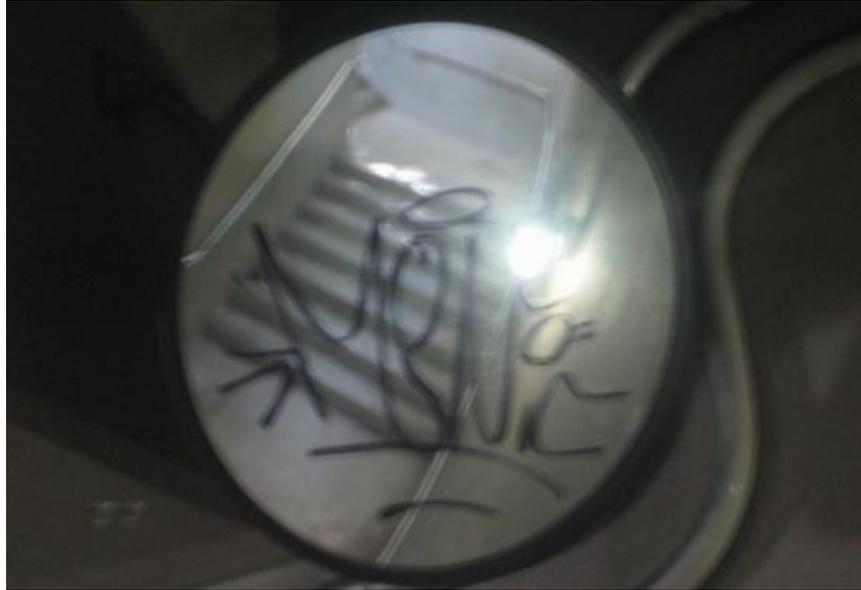
- As seen below in Figure 6, there is a ***corner mirror with graffiti*** on it near the top of the Northbound-side Federal Reserve staircase (10th St. Concourse, East side). The ***presence of the writing diminishes both the utility*** of this safety/comfort measure ***and the patrons' sense of safety*** at this station.

Figure 6 - Graffiti on a corner mirror in the Federal Reserve staircase (Photo 17).

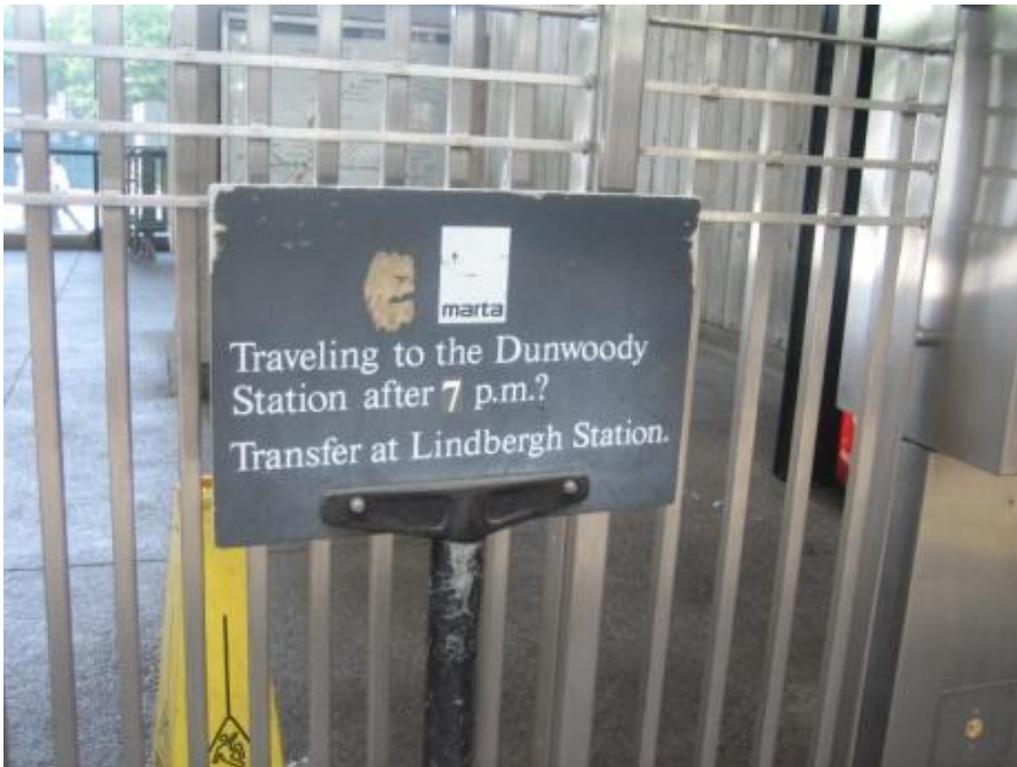
- There is a “late night Dunwoody” **wayfinder**, as seen below in Figure 7, which is **not placed in a readily visible area**. During field work, this sign was observed to be on the concourse level standing against the security fencing at the southern faregates near the Southbound escalator. Also, **“Dunwoody” should read “North Springs”**.

Figure 7 - Late night Dunwoody wayfinder in low visual traffic area (Photo 24).

- **Install bike parking wayfinding signage** within the canopied area of the station and also at the faregates on the Federal Reserve Concourse.
- **Re-orient displays** on large pillars so that the bus information faces the faregates or concourse entry/exit.
- **Replace the “Dunwoody” text** on the late night wayfinder with a “North Springs” **and relocate this wayfinder** next to the main display within the Main Concourse that forms a line with both sets of faregates.
- **Remove “Free Parking” sign.**

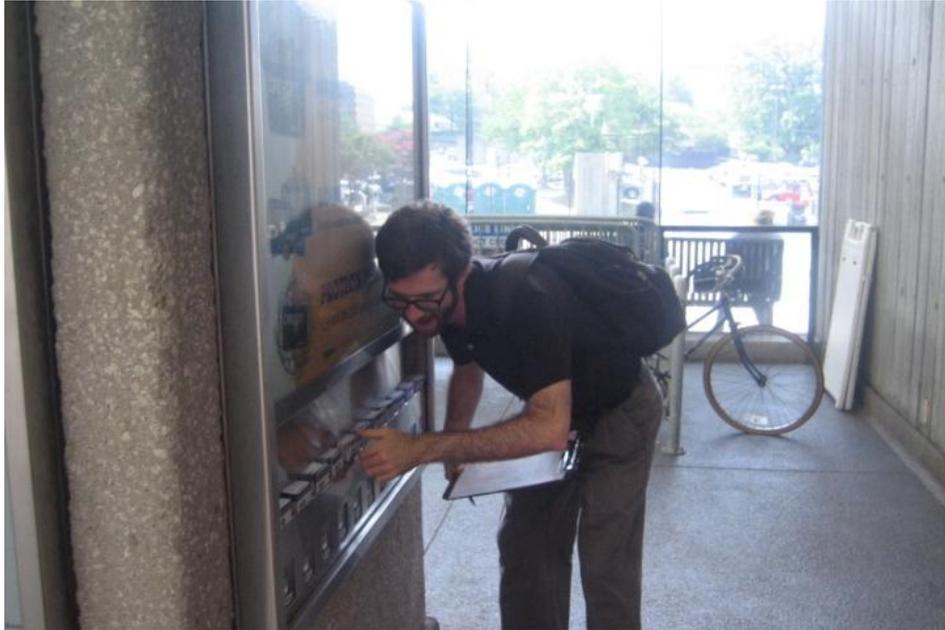
- Within the main station concourse there is a large pillar in the canopied, unpaid area across from either set of faregates. Each face of the pillar has a display case on it; however, in both cases, the **face that contains important bus service information is directed toward the station wall** (Photos 26 & 49). Therefore, the **bus info is not readily visible** to anyone who is not already scouring the station for bus information, as seen below in Figure 8.

Figure 8 - Hard to find bus information hidden behind large pillar (Photo 26).
